# Fish Kill Report

Outlet Channel – Lake Francis to Lake Manitoba – (via Rd 93 N)

June 15, 2012

Laureen Janusz & Jeff Long

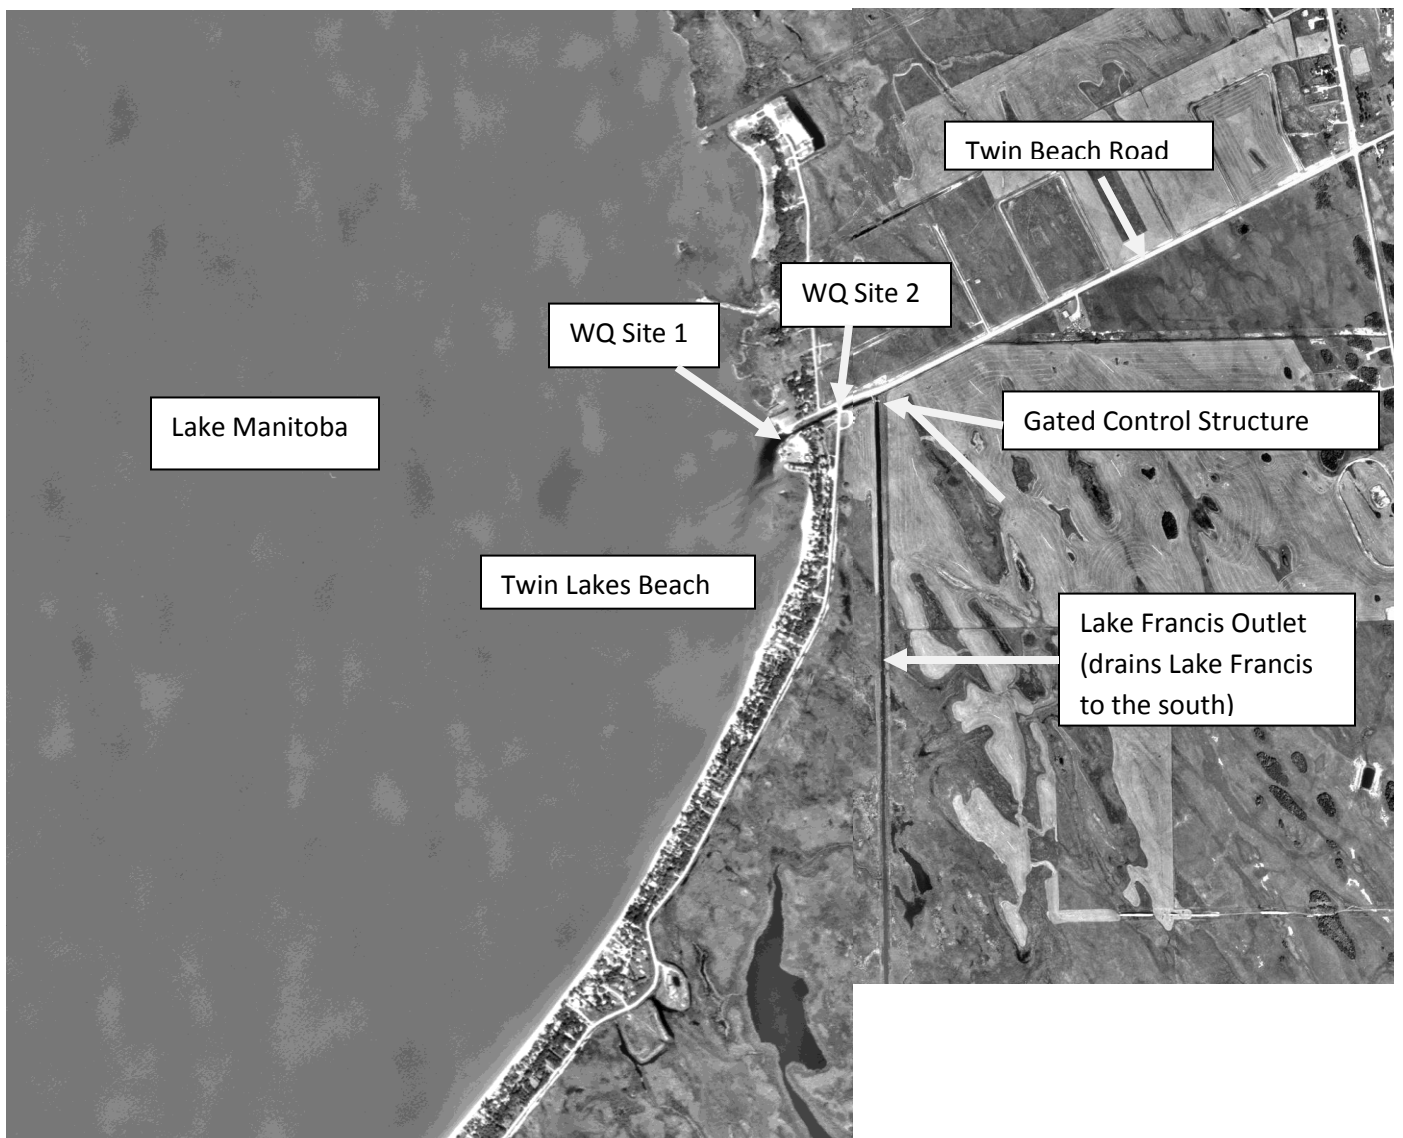
Figure 1

- Fisheries Branch and Water Science responded to reports of a fish kill near Twin Lakes Beach (Fig 1).
- Several reports from concerned public went to government officials and the media (CBC & CTY)

- Some of the dead fish showed various signs of stress prior to mortality (Fig. 7-8).
- The fish showed signs of suffocation (grey gills).
- Water Science Management staff were on site and water quality samples (Table 1) taken from 3 locations along the drain (Fig 1) were submitted to ALS (Table 1).

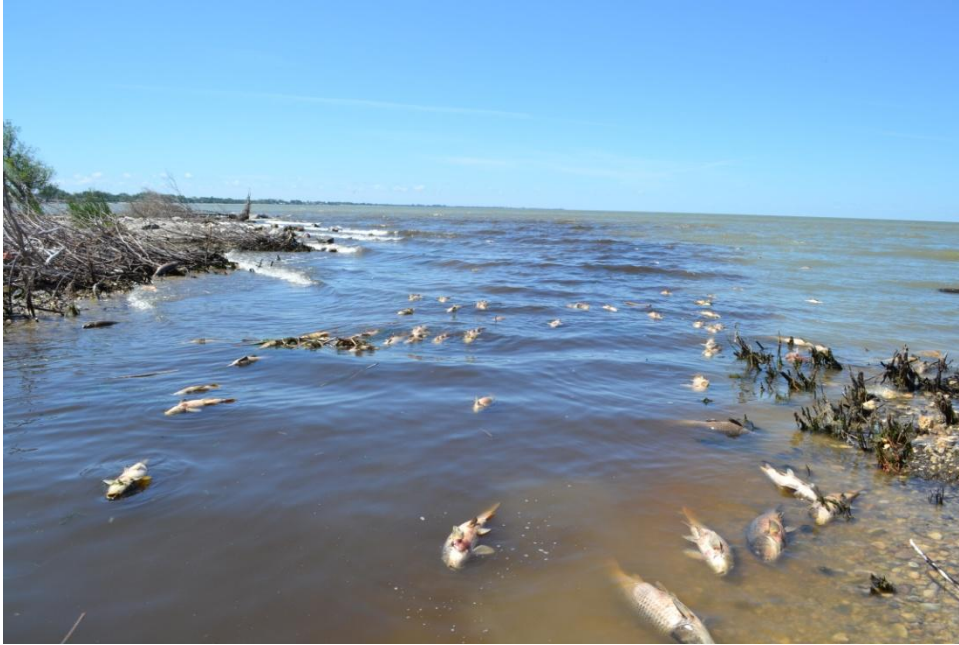
Fig 2. Dead fish at end of channel as it enters Lake Manitoba and site of water quality station 1.

- ≈100-300 dead Common Carp (*Cyprinus carpio*) were found downstream (Figs 2-3) of the gated control structure (Fig 4) to mouth of Lake Manitoba.
  - NB these fish presumably are the result of the gates having been opened at 10:30 (see Fig caption 4).

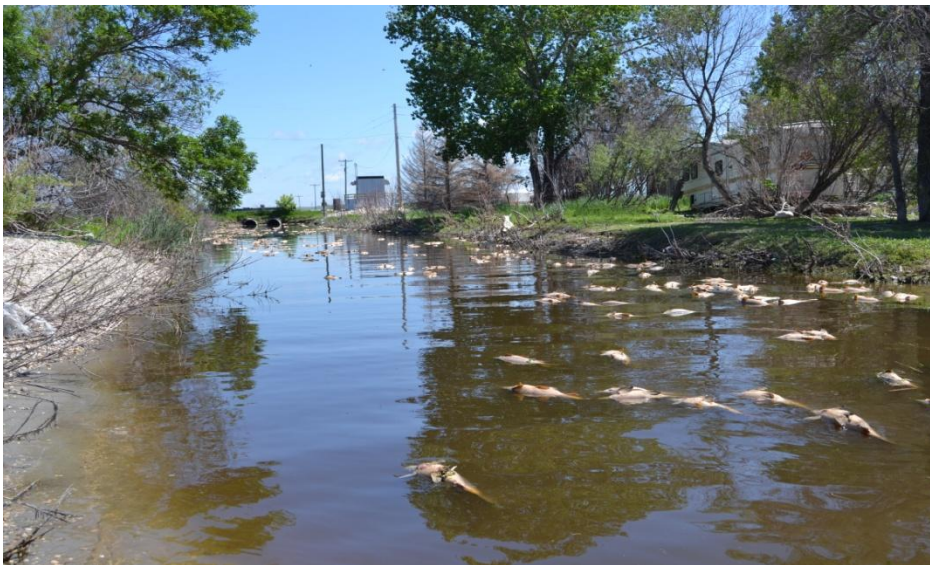
Fig 3. Dead fish looking up the road side drain towards Twin Lakes Beach road crossing. Water quality station 2 is upstream of the culverts.

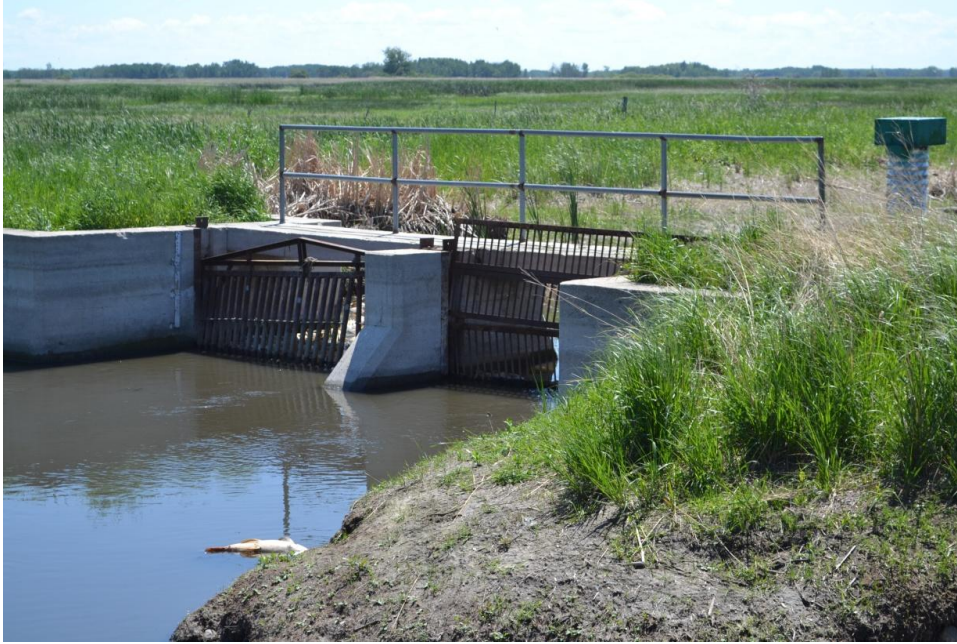
Fig 4. Screened gates at the bottom end of a channel that originates from Lake Francis (Lake Francis Outlet). Water Branch staff indicated that the dead fish were backed up against the upstream side of the gates for approximately 5 metres. Gates were opened around 10:30 am to release dead fish to Lake MB and then again around 2:00 pm. This was the site of water quality station 3. Most of the Common Carp, Freshwater Drum, White Sucker and one live Fathead Minnow were collected just upstream of the gated screen or at the crossing to the screens when the screens were opened to release the fish.

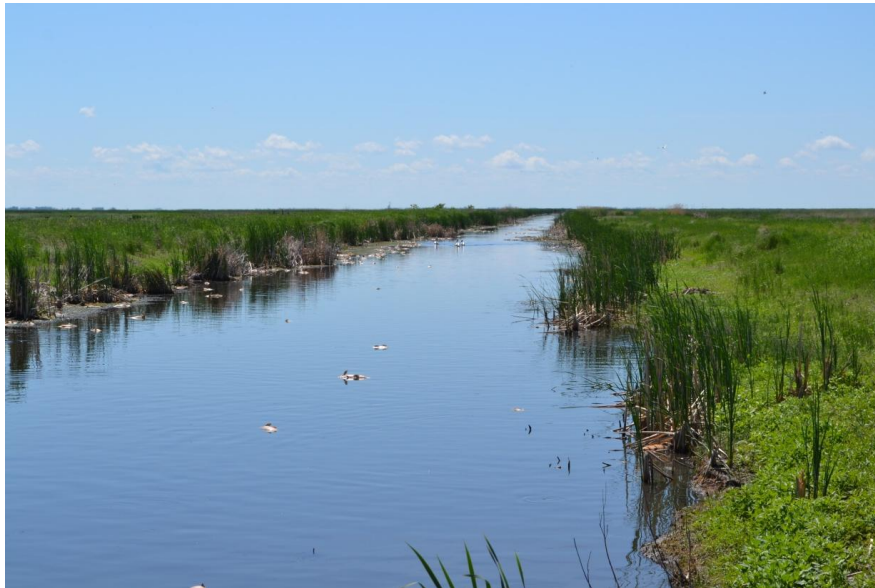
Fig 5. Looking upstream from the gated screens, note some dead carp on the surface in the middle and along the sides of the channel.

- The density of live fish appeared to increase and mortalities decreased (Figs 5-6) as we moved upstream. About 200m upstream of the control structure, on-lookers noted what appeared to be a riffle. This phenomenon was in fact the backs of the carp aggregating in dense clusters engaged in spawning behaviour (see Scott and Crossman, 1997 for a description of this behaviour).

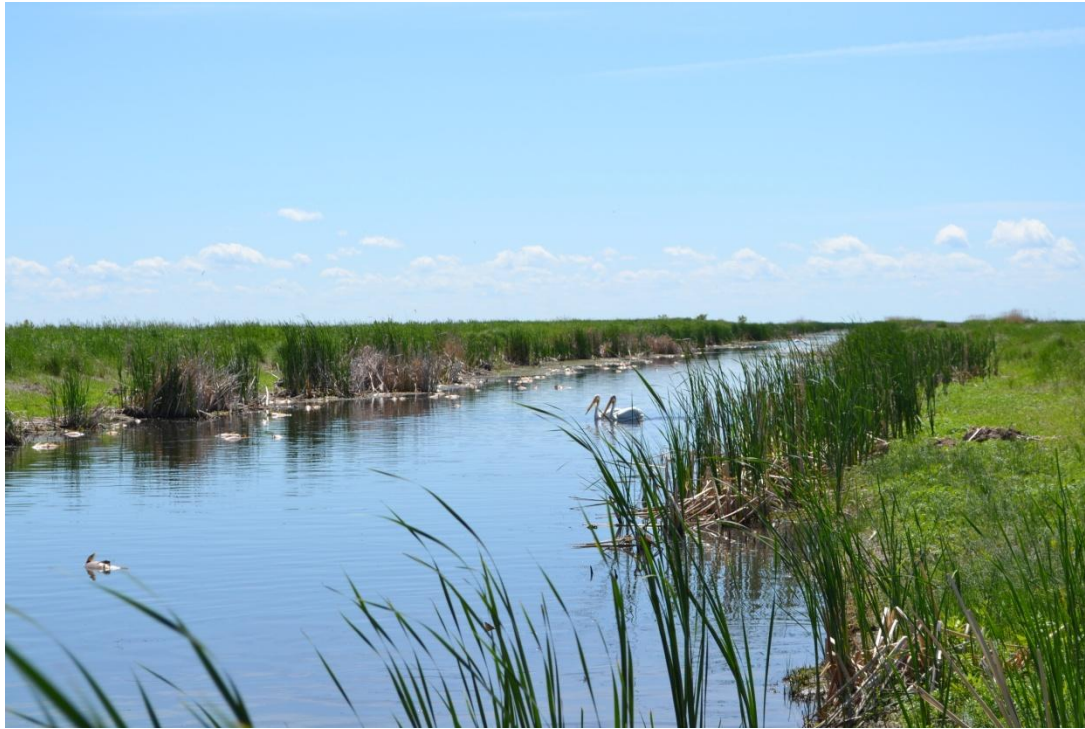
Fig 6. Note Pelicans fishing in channel.

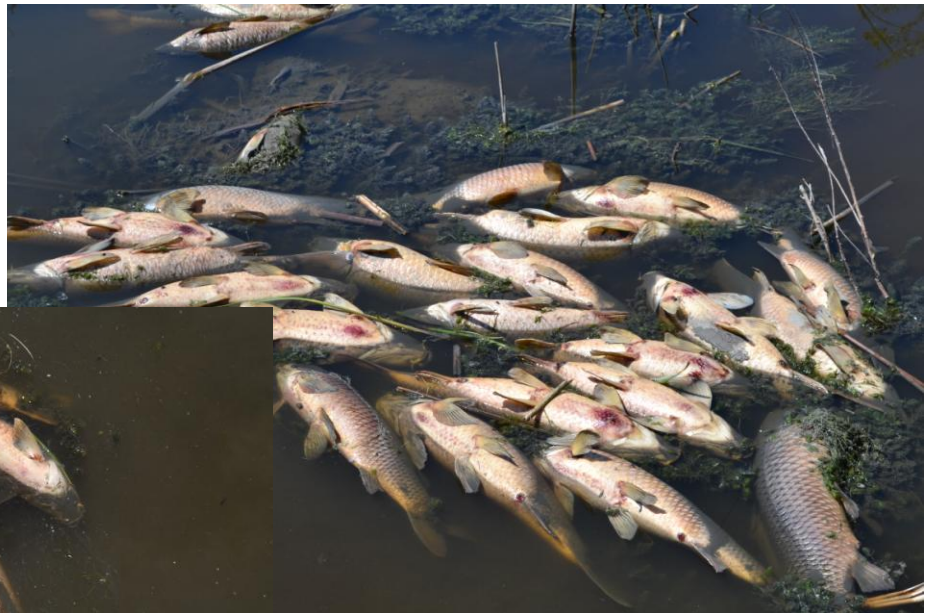
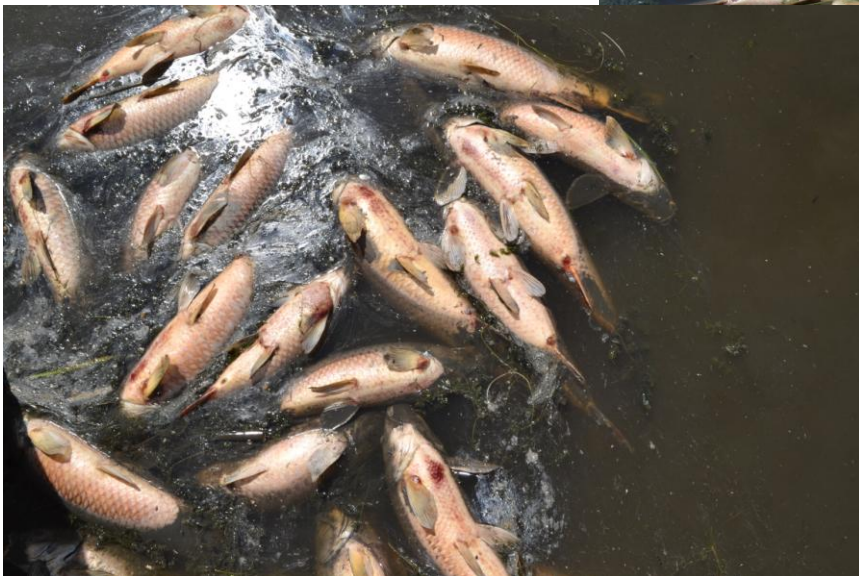
Figs 7-8. Dead fish just below the crossing to the screened gate. On some fish there was haemorrhaging on the ventral side between pectoral fins and a bulbous inflammation at the vent.
